## **“Determination of important hydrological features for Oroklini Lake”**

**Foreseen as part of the project LIFE10 NAT/CY/716 where BirdLife Cyprus is an associated beneficiary**

### **FINAL REPORT**

**November, 2012**

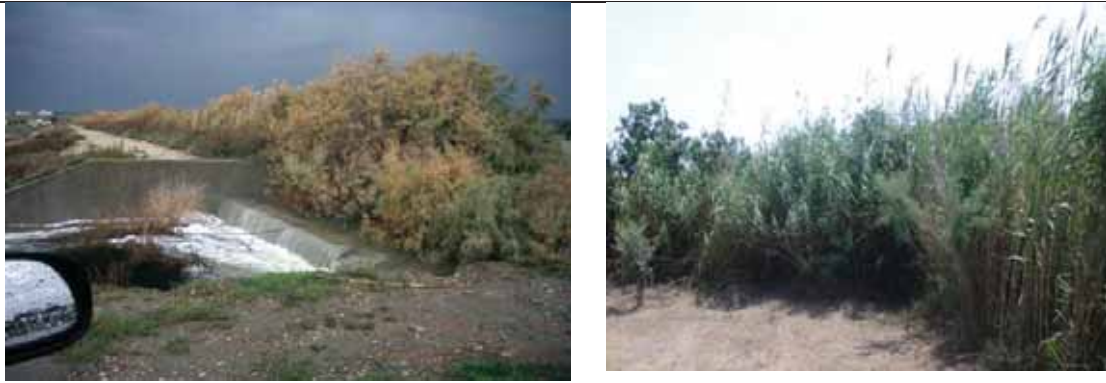
The vegetation on the upstream side of the embankment is so dense that made any site survey extremely difficult. The most difficult part was the area of the weir itself where the vegetation was very dense something that made it impossible to check the weir for leakage or consider the need for a sluice gate (Photo 10 – right and Photo 11). The situation before the clearing of the vegetation is given by Photo 10–right, which can be compared with a photograph taken in 2008 (Photo 10 – left).

**Photo 10: Weir during wet year, looking West (After Haycock Hydrology report, Oroklini Marsh, 2008) (Left) and same area on the 21<sup>st</sup> of June 2012 (Right)**

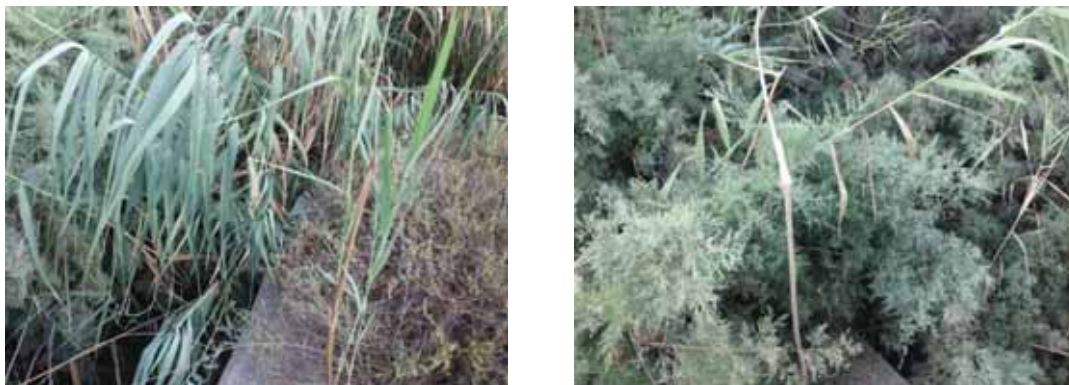
**Photo 11: Conditions at the Weir on 16<sup>th</sup> August 2012, South view (Left) and same area, North view (Right)**

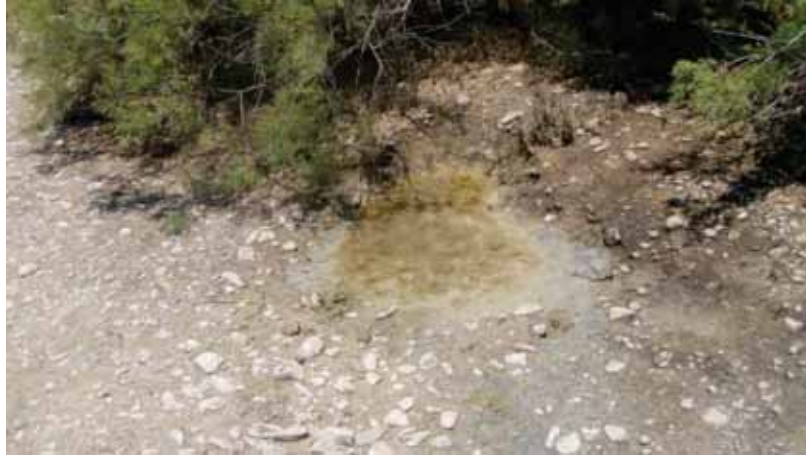
**Photo 12: Non active (12/6/2012) seepage point at the lower berm of the bank at 170m from western most point**

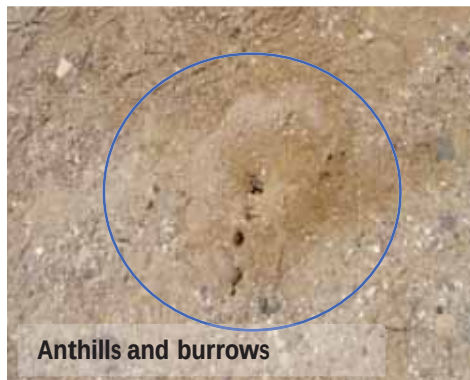
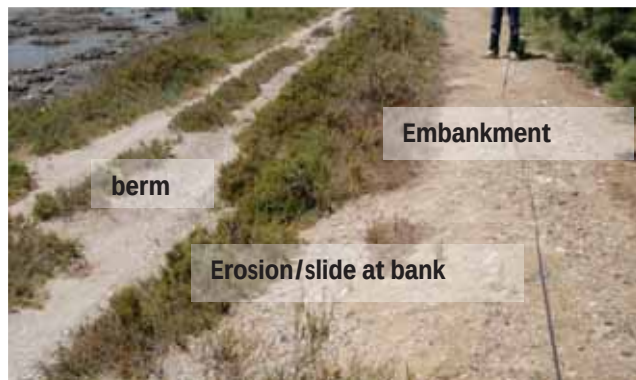
**Photo 13: Photo 3: Burrows and anthills at 45m from western most point on embankment (Left) and erosion/slide at 75m (Right)**

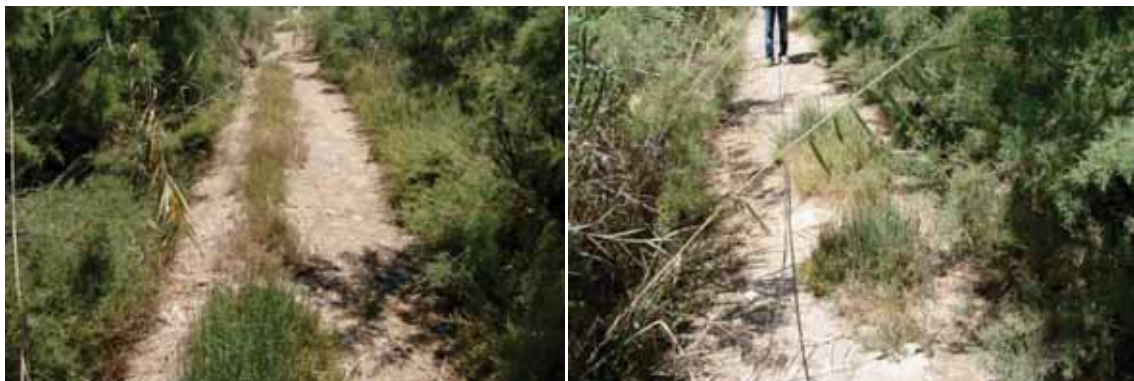
**Photo 14: At 135m from western most point showing subsidence between 120 -230 m with increased vegetation in subsided area**

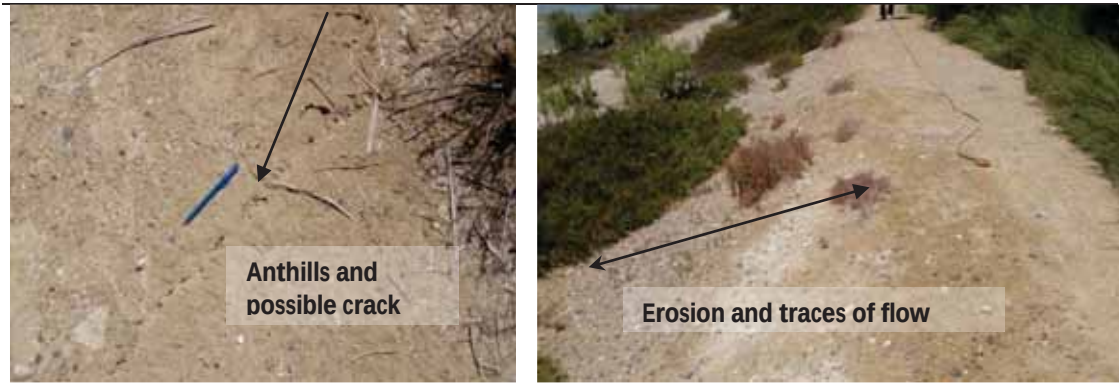
Photo 15: Anthills and possible minor crack on bank at 225m (Left) and erosion and traces of flow (salt deposition) at 250m (Right).

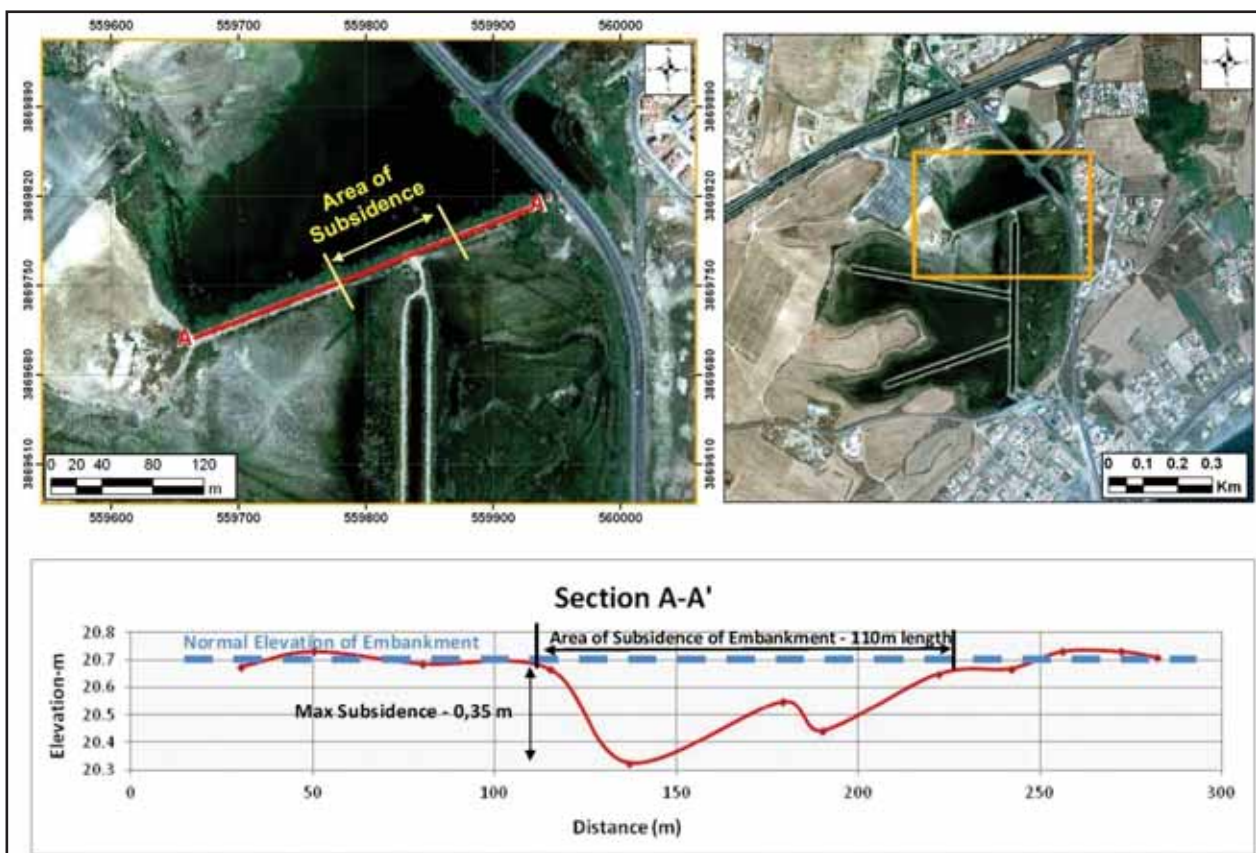
Diagram 6: Subsidence of the embankment observed in the field and measured by the topographic survey

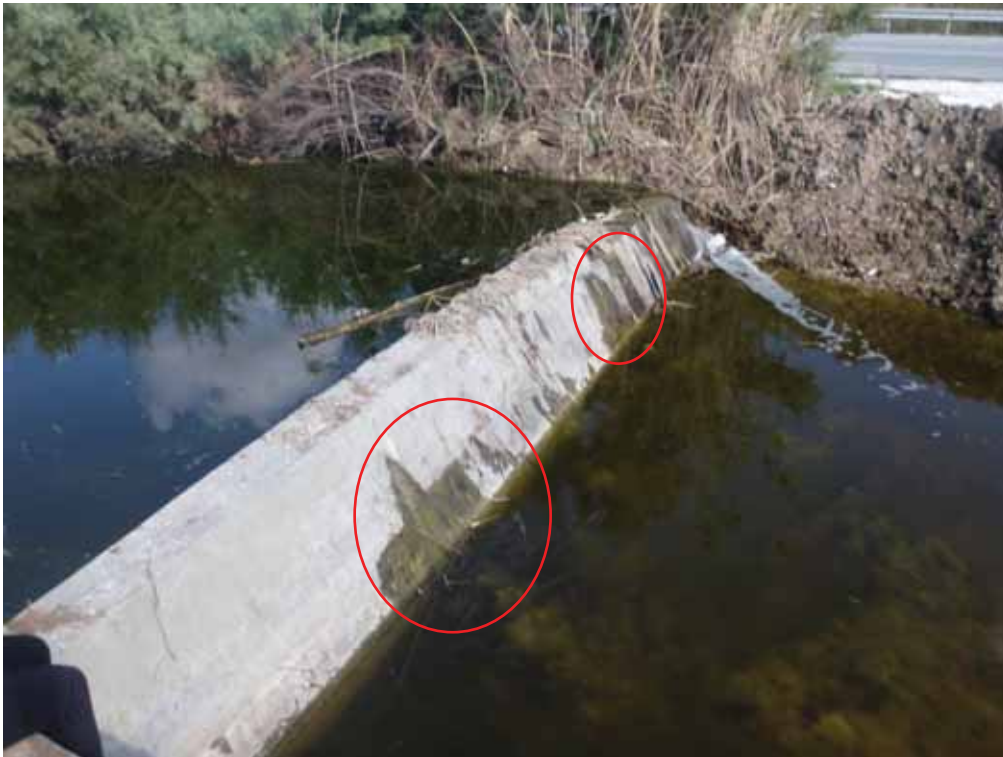
**Photo 16: Minor seepage shown on the spillway wall during the spill of the lake on November 14<sup>th</sup> 2012**

As a result of the above observations it is recommended that:

- Allowance should be made for a sluice gate as shown in detail in the section further below under the proposed management works.
- The lowered by 15-20 cm of the 1,5 – 2,0 meters eastern part of the spillway crest should be reinstated to its original elevation.
- The seepage on the spillway wall should be fixed during the construction works that will be undertaken at the weir. Insulating material (asphalt or other more suitable material) should be placed on the upstream part of the spillway. Cement injection may also be considered.
- The CYTA wire which was found to cross the weir and the bottom of the lake (Photo 17-right) should be further investigated with CYTA and be removed.
- The weir should be maintained clear of the vegetation so that the spillway operates effectively.

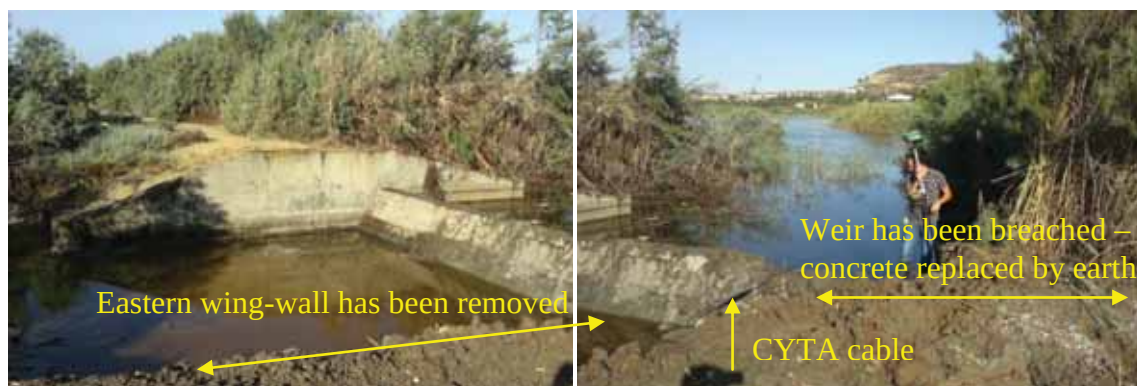
BirdLife Cyprus, followed the Consultant’s recommendation that it was imperative, not only for the needs of this study, to have the area around the weir cleared of the vegetation which was totally obscuring it, but also for providing the conditions of the weir to work efficiently as a spillway and, arranged the clearing of the vegetation from the area within and around the weir on the 10<sup>th</sup> of October. The weir was uncovered and details of its condition were revealed (Photo 16 and 17).

Photo 17: Conditions at the Weir on the 10<sup>th</sup> October 2012, West view (Left) and north-west view (Right)

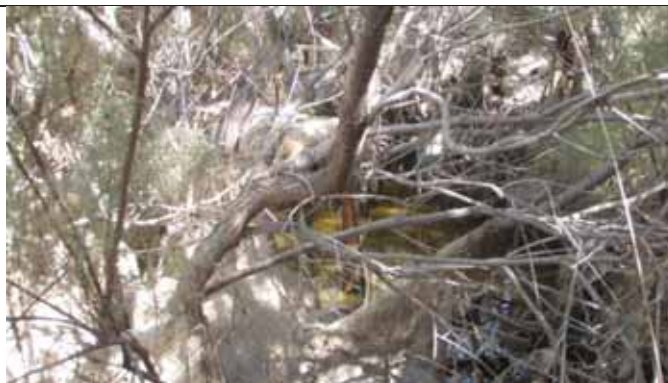
**Photo 21: Present conditions of main north- south ditch at the location of the old pumping station and where the overflow weir and sluice gate is envisaged.**

To ensure that the drainage is clear beyond the point of the south end of the N-S ditch (taken at the location of the old pump house) one would need either to provide a topographic gradient towards the sea, by lowering the topography downstream of the southern end (including the culvert(s) accordingly, or raise the elevation of the bottom of the ditch at a reasonable gradient from the south end of the ditch up to a point about 30m to the north.
