# ACTION PLAN FOR OROKLINI LAKE, CYPRUS

## ACTION PLAN FOR OROKLINI LAKE, CYPRUS

**This Action Plan has been produced as part of the project “Restoration and Management of Oroklini Lake SPA (CY6000010) in Larnaca, Cyprus” which is co-funded by the LIFE financial instrument of the European Union**

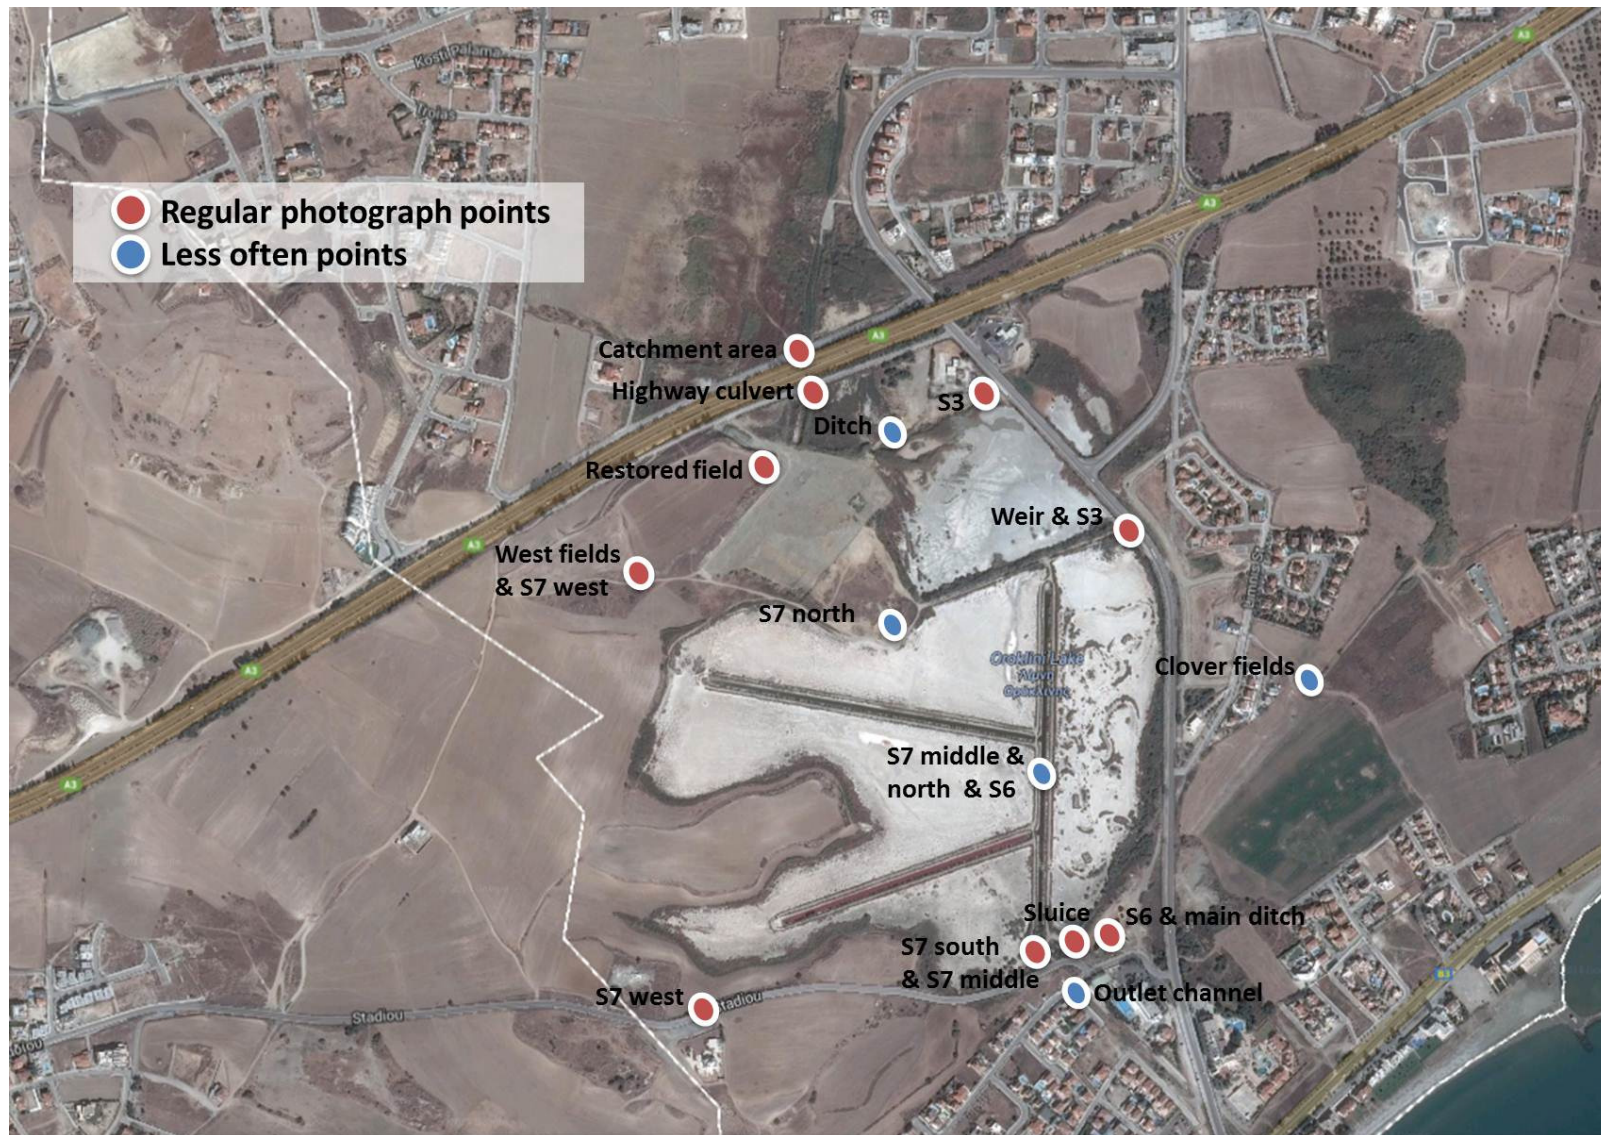
Figure 6: Locations used for fixed point photography
